Engineering for Polar Operations, Logistics, and Research (EPOLAR)

Low-Temperature Flex Durability of Fabrics for Polar Sleds

Final Report

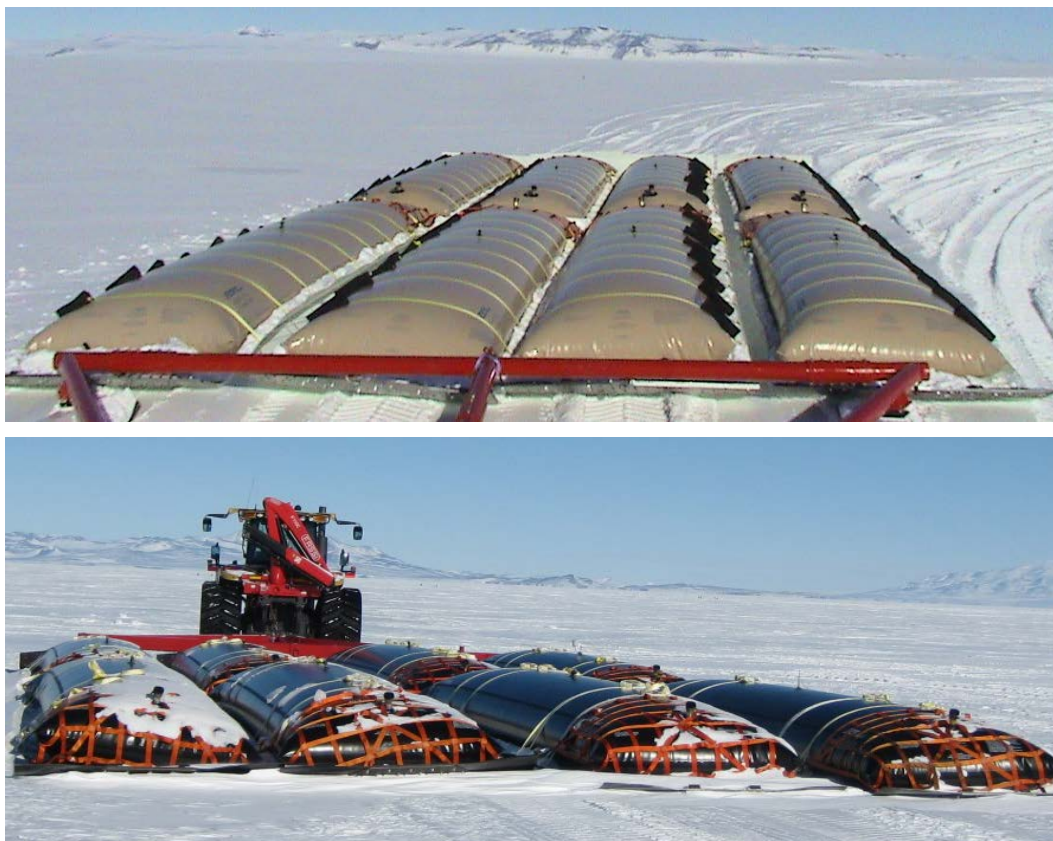
Figure 1. Fuel-bladder sleds ready for outbound transport on the South Pole Traverse from McMurdo Station to South Pole Station. The sleds consist of dual 3000 gal. fuel bladders strapped to 8 ft wide × 68 ft long × 0.5 in.-thick HMW-PE sheets towed through steel towplates. Sleds with black bladders produce lower sliding friction owing to solar gain, so SPoT is systematically replacing older tan bladders with black ones constructed from similar polyurethane-coated fabric.

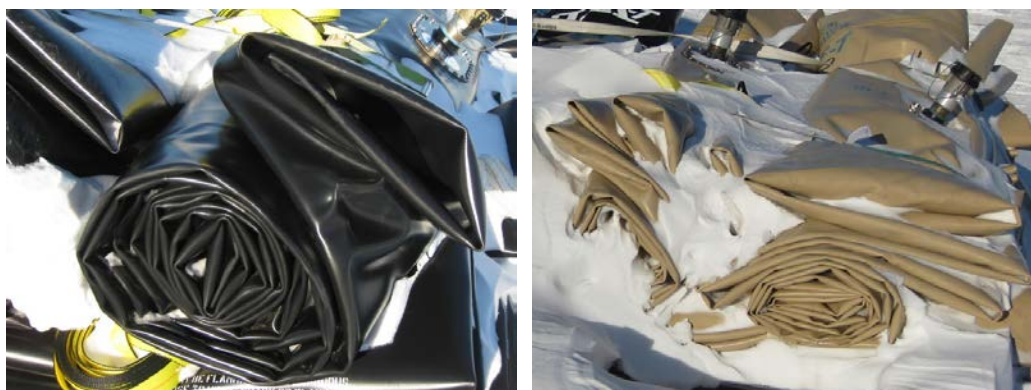
Figure 2. Fuel bladders removed from over-winter storage at McMurdo prior to inspection. Note the tight folds at corners despite efforts at South Pole to roll the emptied bladders rather than to fold them.

Does time-scale matter? Bladders left folded over-winter in McMurdo would have 6–7 months to accommodate stresses at folded corners (Figure 2). Material initially under compression in the sharp-radius interior corners probably relaxes to a neutral state during this time. When unfolded at the start of the next season, the corner would then experience high tensile stresses as it opens.

for a day before being unfolded, it is possible that the resulting tensile stresses are sufficient to crack the material in some fraction of the many such tight folds that occur in each bladder (Figure 2).

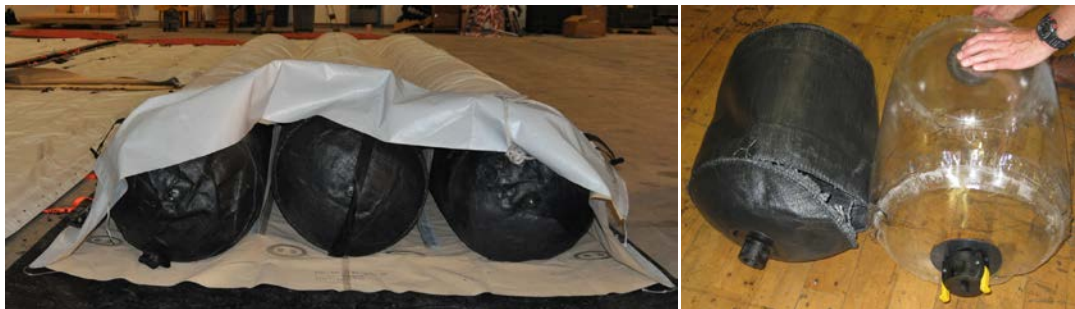
Figure 4. Construction of tube-in-pouch suspension for ARCS. Left: cylindrical air-filled pontoons (black) slide inside fabric pouches (gray), which bolt between HMW-PE sheets and wooden cargo decks. Right: each pontoon consists of a woven outer shell (black) and an impermeable inner liner (clear) as shown with this short sample.

Figure 10. Low-temperature compression tests on a sample ARCS pontoon built by FFF using materials designated Samples 14 and 16 here (Weale et al. 2011). The photo on the right in Figure 4 shows the liner-shell construction of this pontoon sample.

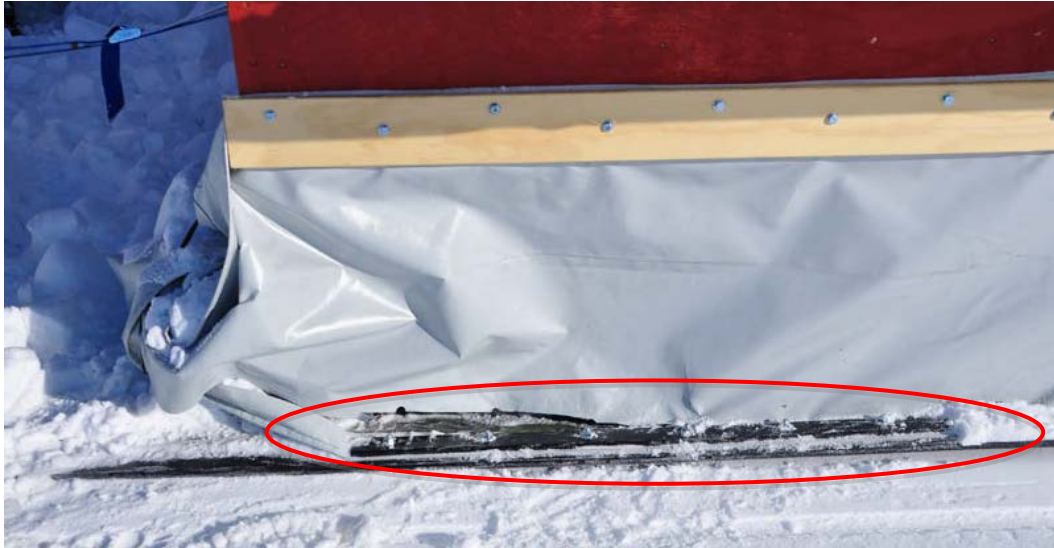
Figure 5. The polymer-coated fabric used for prototype ARCS pouches was stiff to handle at low temperatures and tended to crack when flexed over rough snow. Two Grit12 pouches tore along joints with underlying sleds (tear circled in red here), a result of brittle fabric behavior at low temperature and stress concentrations at the corners.

snow (Figure 5). We thus sought more durable pouch fabrics, and FFF provided several candidate materials to evaluate using Gelbo tests.

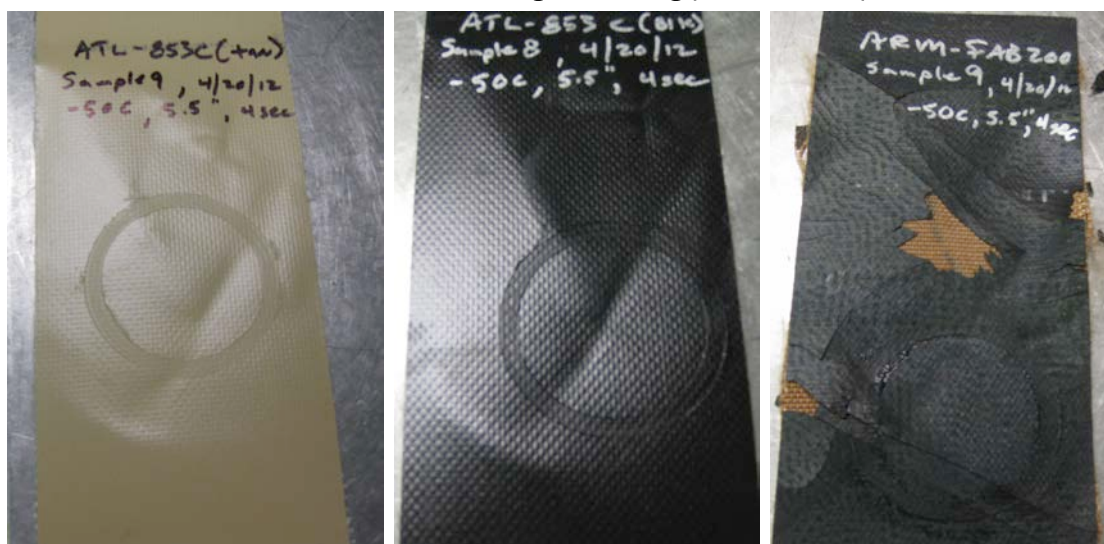
Figure 9. ARM-FAB200 specimens shattered and delaminated after one Gelbo cycle at -50°C (right), while specimens of existing bladder materials (ATL-853C) survived 100 cycles at -50°C without cracking and leaking (left and center).

By contrast, we were disappointed in the performance of the ARM elastomer-coated fabric, having expected it to perform better than the ATL materials. The material cracked and leaked after only one cycle at -40°C (three repeated tests) and shattered after a single cycle at -50°C. Table 3

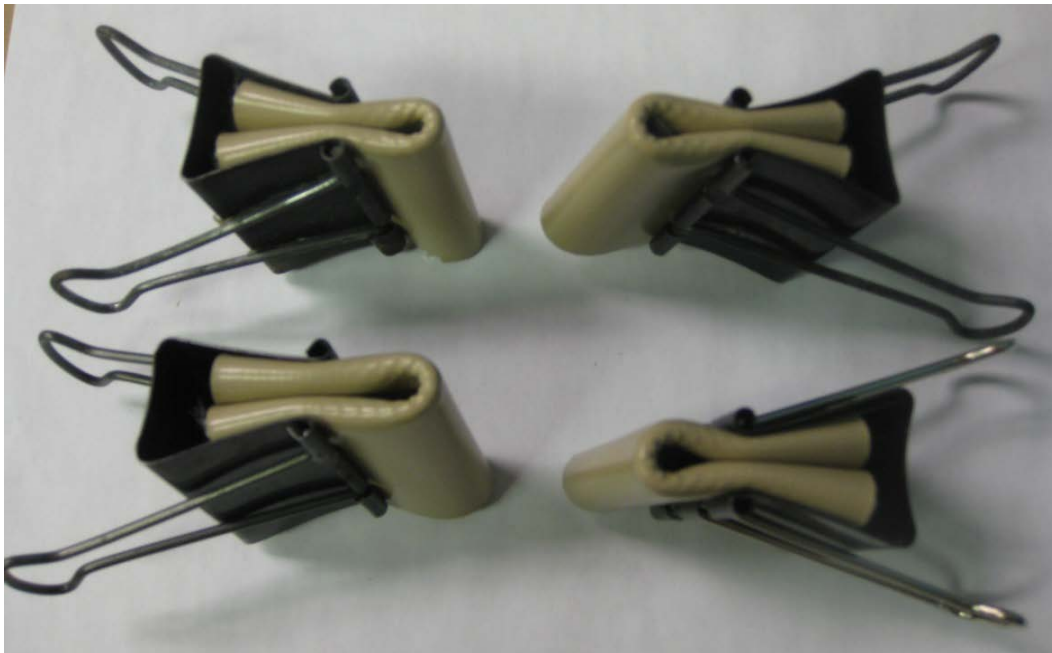
Figure 12. Specimens of bladder material double folded, clamped, and allowed to relax at room temperature.

We attempted to simulate these conditions by double-folding specimens at room temperature, clamping them and allowing them to relax at room temperature for 1–2 days (Figure 12). We then cold-soaked the folded specimens at -40°C for several hours and abruptly opened them at -40°C . The material on the inside of the double folds was creased, but no cracks formed, and the specimens did not leak (Figure 13). Interestingly, the specimens tended to fold-up after being opened, suggesting that some stress-relaxation did occur while they were clamped at room temperature (Figure 14).

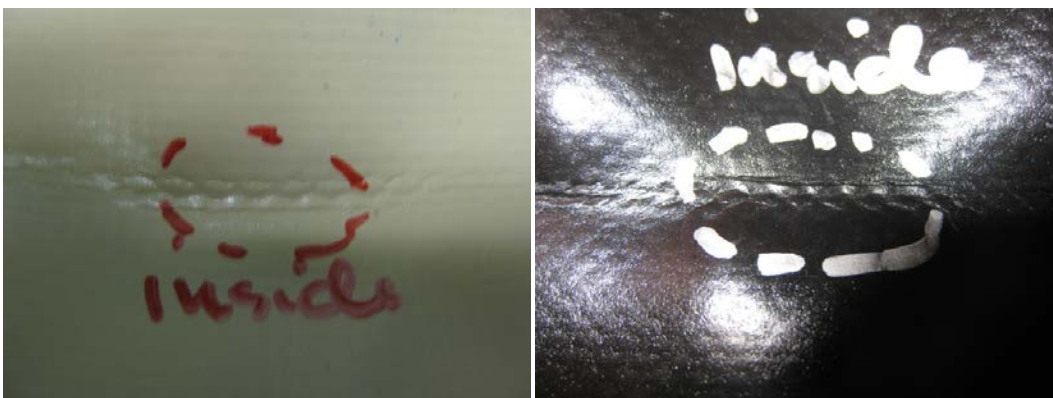
Figure 13. Bladder material creased but did not crack and leak at the inside corners of double folds when opened at -40°C .

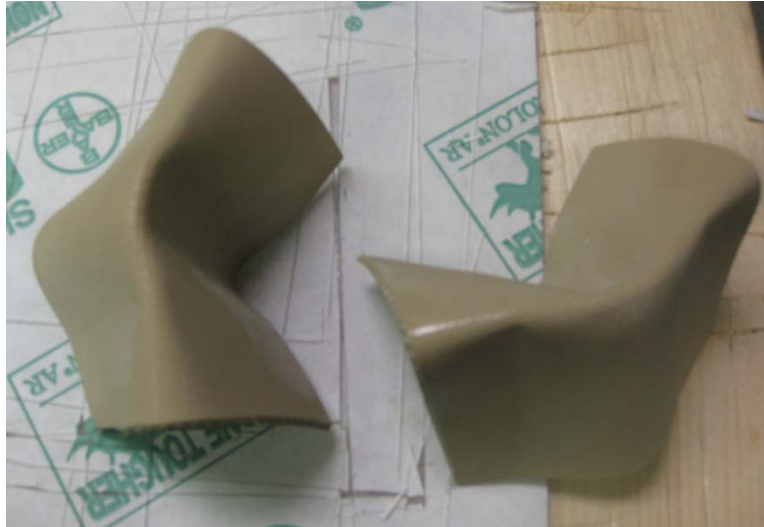
Figure 14. Folded specimens tended to fold-up partially after opening, suggesting some stress relaxation did occur from clamping for 1–2 days.
